PLAY AREA SAFETY INSPECTION REPORT

Adderley Parish Council

25 June 2014

Site Name : Adderley Play Area

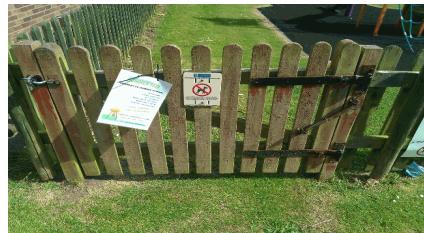
Task : Replace decayed components where possible, and plan replacement of item. Check on a routine basis, especially at ground or foundation level		
Gate Risk Score : 3 Risk Level : Very Low	Entrance	Finding : RoSPA recommend the provision of a minimum of two pedestrian gates to reduce the risk of intimidation and bullying

Finding Date : 25/06/2014 Task : Monitor and check on a routine basis taking remedial action if necessary.	Low	4
Gate Risk Score : 3 Risk Level : Very Low	Entrance	Finding : Entrapment on side(s) of gate

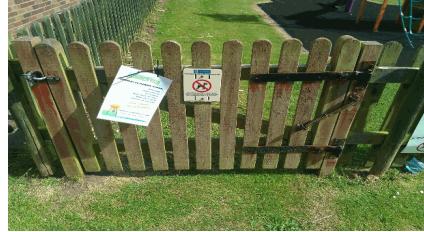
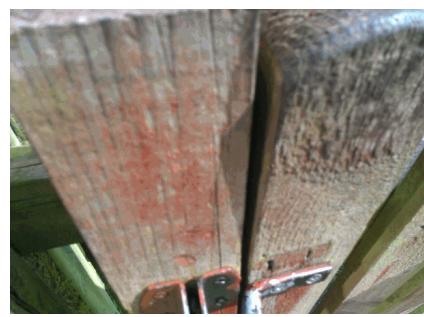
Finding Date : 25/06/2014

Task : Adjust gate/posts/fit new rubber buffer to ensure a spacing of at least 12mm throughout the range of the gate to remove the entrapment. The 12 mm gap also should apply on the hinge side of the gate	Low	6
Site				
Sign Risk Score : 2 Risk Level : Very Low	Signage	Satisfactory

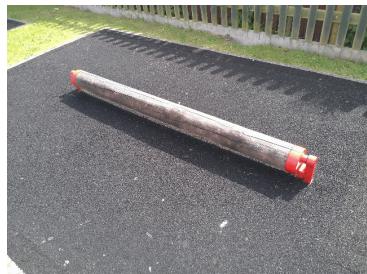
Agility - Roller Beam

Risk Level : Low

Risk Score : 5

The item meets with the requirements of the relevant standard where this may be tested on site without dismantling or destruction.

The surfacing meets the requirements of the relevant standard.

Comments, action or control required	Risk Level	Risk Score ‡
Equipment	No remedial maintenance work is required at this time.		
Surfacing - Wet Pour	No remedial maintenance work is required at this time.		
The overall risk for this item at the time of inspection:		Low	5
‡ For Risk Score see Report Notes

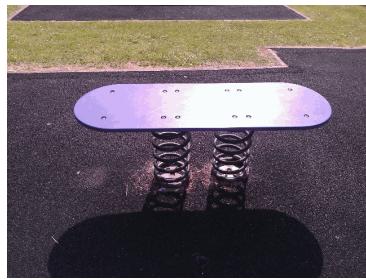
Agility - Spring Plank

Risk Level : Low

Risk Score : 5

Comments, action or control required	Risk Level	Risk Score ‡
Equipment	No remedial maintenance work is required at this time.		
Surfacing - Wet Pour			
Finding : Surface - Cracking		Low	4
Finding Date : 25/06/2014			
Task : Make good surface			
The overall risk for this item at the time of inspection: ‡ For Risk Score see Report Notes		Low	5

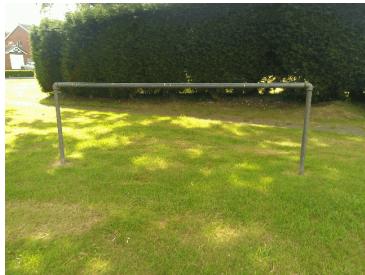
Ball - 5aside Goal

Risk Level : Medium

Risk Score : 8

Comments, action or control required	Risk Level	Risk Score ‡
Equipment	No remedial maintenance work is required at this time.		
Surfacing - Grass	No remedial maintenance work is required at this time.		
The overall risk for this item at the time of inspection:		Medium	8
‡ For Risk Score see Report Notes

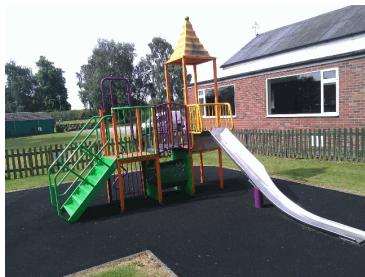
Multiplay

Risk Level : Low

Risk Score : 6

Comments, action or control required	Risk Level	Risk Score ‡
Equipment	No remedial maintenance work is required at this time.		
Surfacing - Wet Pour	No remedial maintenance work is required at this time.		
The overall risk for this item at the time of inspection:		Low	6
‡ For Risk Score see Report Notes

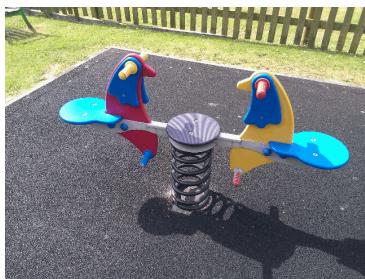
Rocker - Seesaw

Risk Level : Low

Risk Score : 4

The item fails to meet the requirement of the relevant standard.

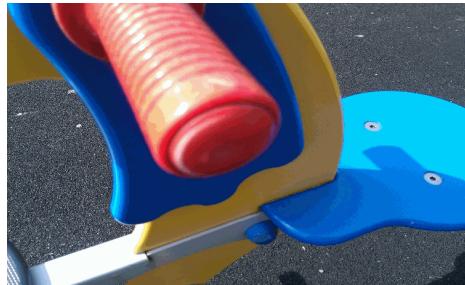
Comments, action or control required	Risk Level	Risk Score ‡
Equipment			
Finding :	Protruding handles/footrests	Very Low	
Finding Date :	25/06/2014

Task :	No Action Required		
Surfacing - Wet Pour			
Finding :	Surface - Cracking	Low	4
Finding Date :	25/06/2014

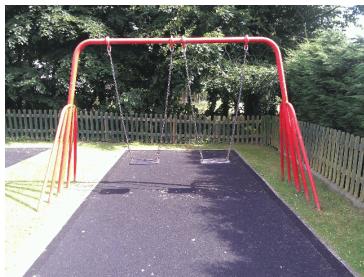
Swing - Junior

Risk Level : Low

Risk Score : 5

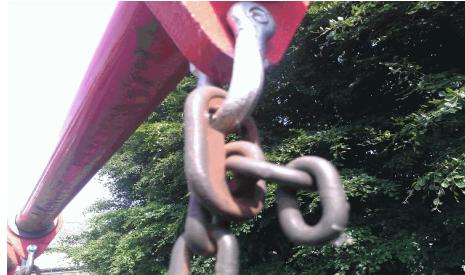
Comments, action or control required	Risk Level	Risk Score ‡
Equipment			
Finding :	This type of swing chain attachment has in some cases been associated with chain detachment. The key link should be examined closely by the client on regular inspections and changed if even slight wear has occurred. There must be at least two links hanging down. Note it will be necessary in most cases to inspect all swings over 1.80 metre height by use of steps or a ladder	Low	4
Finding Date :	25/06/2014

Task :	Monitor and check on a routine basis		
Surfacing - Wet Pour			
Finding :	Surface - Cracking	Low	4
Finding Date :	25/06/2014

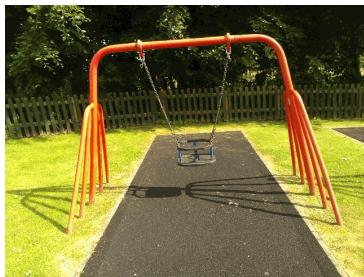
Swing - Toddler

Risk Level : Very Low

Risk Score : 3

Comments, action or control required	Risk Level	Risk Score ‡
Equipment			
Finding :	This type of swing chain attachment has in some cases been associated with chain detachment. The key link should be examined closely by the client on regular inspections and changed if even slight wear has occurred. There must be at least two links hanging down. Note it will be necessary in most cases to inspect all swings over 1.80 metre height by use of steps or a ladder	Low	4
Finding Date :	25/06/2014		
Task :	Monitor and check on a routine basis		
Surfacing - Wet Pour			
Finding :	Surface - Cracking	Low	4
Finding Date :	25/06/2014

Task : Make good surface		
The overall risk for this item at the time of inspection: ‡ For Risk Score see Report Notes	Low	4
